NORTH RIVER FLOOD PLAIN MANAGEMENT STUDY

Colrain, Massachusetts

United States
Department of
Agriculture

December 1990

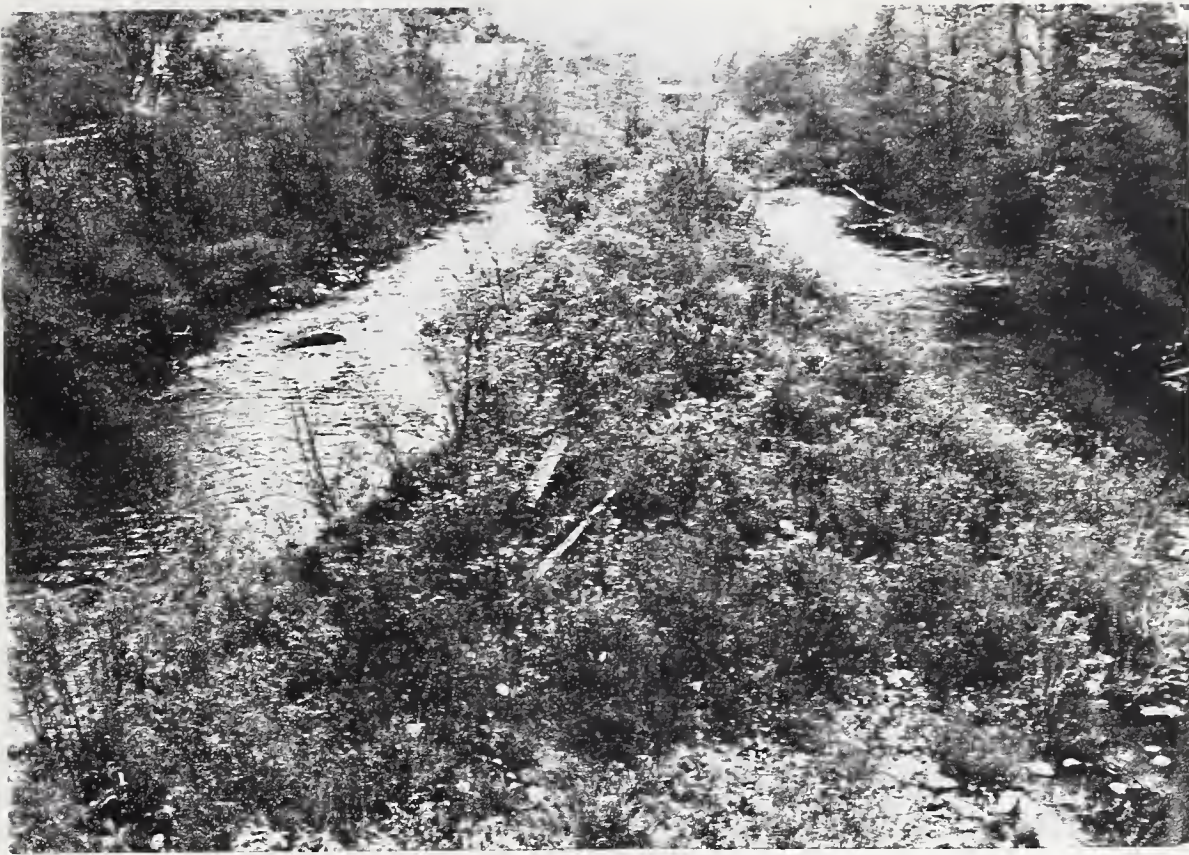
Problem Area #1

Gravel bar accumulation below Route 112 bridge.

Location: Downstream of the Route 112 bridge near the Vermont state line.

A gravel bar is located downstream of the Route 112 bridge in the center of the channel (approximate size--500 feet long, 40 feet wide, and an average of 2 feet thick). Judging by the size of the trees and brush, the gravel bar has been in place 10 to 15 years. The vegetation has become a trap for the bedload, thus aggravating the sediment accumulation. The stream flows on both sides of the gravel bar and causes erosion of the right bank for 100 feet below the bridge. After the stream channels join together, gravel is deposited along the right side of the stream for a distance of approximately 300 feet downstream. Gravel has not deposited in the channel upstream or underneath the Route 112 bridge. Old bridge abutments are located approximately 50 feet downstream of the Route 112 bridge on both banks. If the old bridge had a pier located in the middle of the stream, any remains of the pier could be the cause of the gravel bar formation.

Under normal runoff conditions the stream flow and sediment balance appears to remain stable. High stream flows could cause further erosion of the right bank and sediment movement. The vegetation on the gravel bar will continue to trap bedload and increase the thickness of the accumulation.

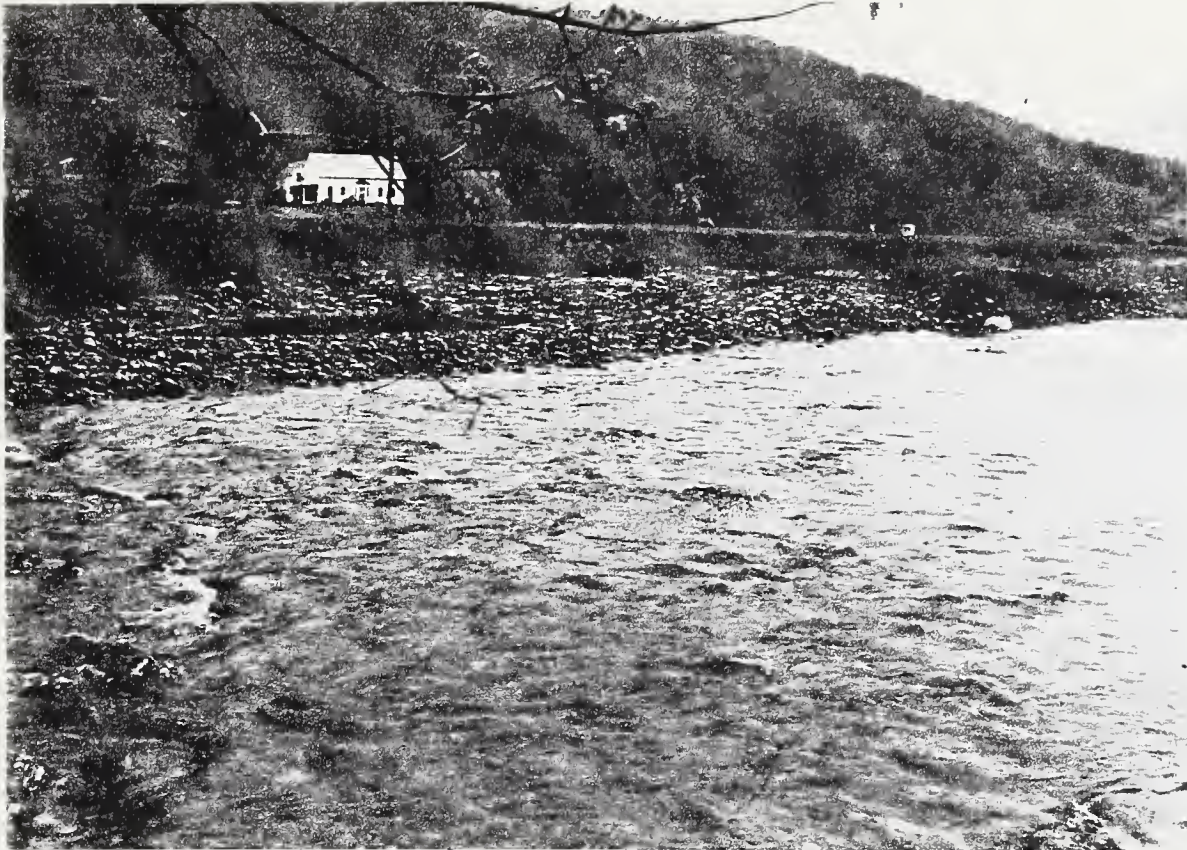
Problem Area #2

Streambank erosion on right bank along hayland.

Location: Approximately 1500 feet upstream of the Franklin Hill Road crossing.

Stream degradation will continue with the right bank eroding and sediment transported downstream. The stream will try to decrease its channel grade by increasing the meander length. Erosion of the right bank will continue to move into the field and progress downstream. The streambank erosion rate is estimated at 5 to 10 feet per year which results in approximately 1 acre of farmland lost every 10 years.

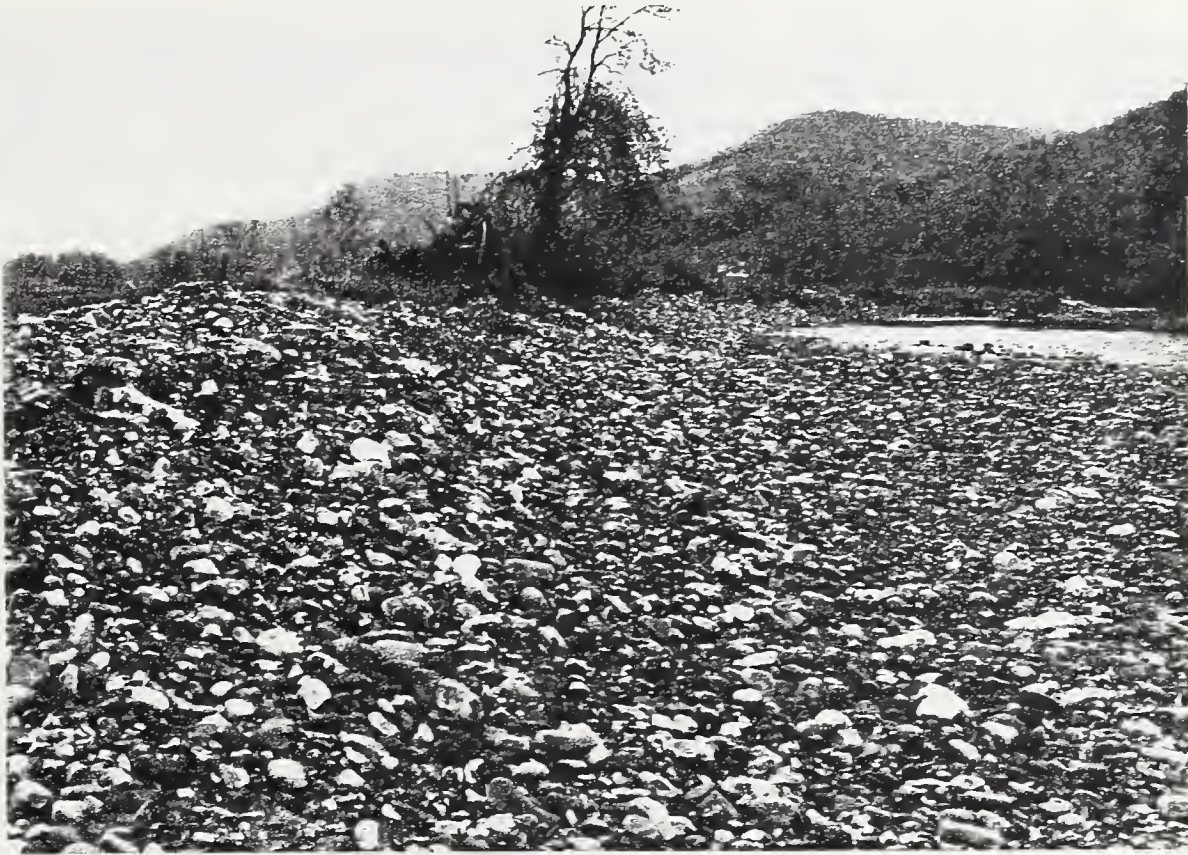
Problem Area #3

Streambank erosion with gravel deposits graded to protect the bank at the lower end.

Location: Stream reach near the Fort Morrison site on the Colrain USGS Quad.

The land lost from meander cutting throughout this area amounts to approximately another 1/10 of an acre per year. This means the loss of about \$1,000 annually in tillable land. Dealing with erosion damages from flood flows and removal of infertile overwash costs these farmers another

\$1,000 annually. Total damage for this problem area is about \$2,000 per year.

The fields will continue to erode in this reach. Gravel and sediment are being deposited in the lower end of the problem area and contributing toward further erosion on the right bank at the downstream end. Sediment will continue to build up and create additional changes downstream.

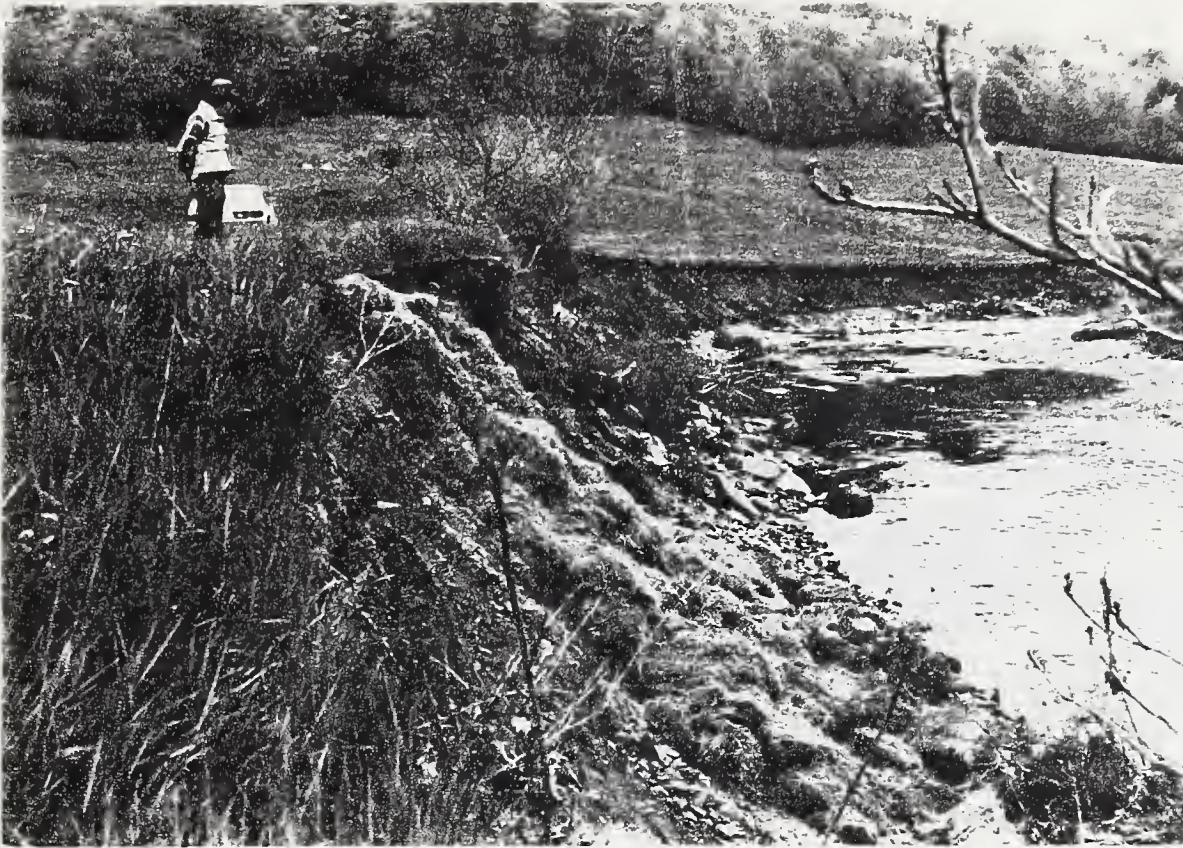
Problem Area #4

Streambank erosion along the left bank.

Location: Streambank erosion east of the North River Cemetery.

A large meander has formed, causing the left streambank to erode for a distance of 600 feet with a bank height of approximately 20 feet. According to the landowner and field measurements, the meander has cut 100 feet laterally into the streambank over the past 25 years. The upland was once used for hayland, but has been converted to pasture. The stream flow deflects off the eroded area on the left bank and has caused the right bank to start eroding downstream. The area on the inside of the meander (right side) has grown up with brush and accumulated debris. This restricts the stream flow and directs the river towards the eroded area; thus causing additional erosion of the bank. As the left bank erodes, the right side of the stream accumulates gravel which presently amounts to at least 4,000 cubic yards.

The stream degradation process will continue with the meander length increasing in order to reduce the channel slope to a more stable grade. The left streambank will continue to erode into the pasture. Sediment will continue to build up on the right side and also be transported downstream. On the area inside the meander, brush will become denser and more debris will accumulate; thus reinforcing the barrier which deflects the stream flow toward the eroded area.

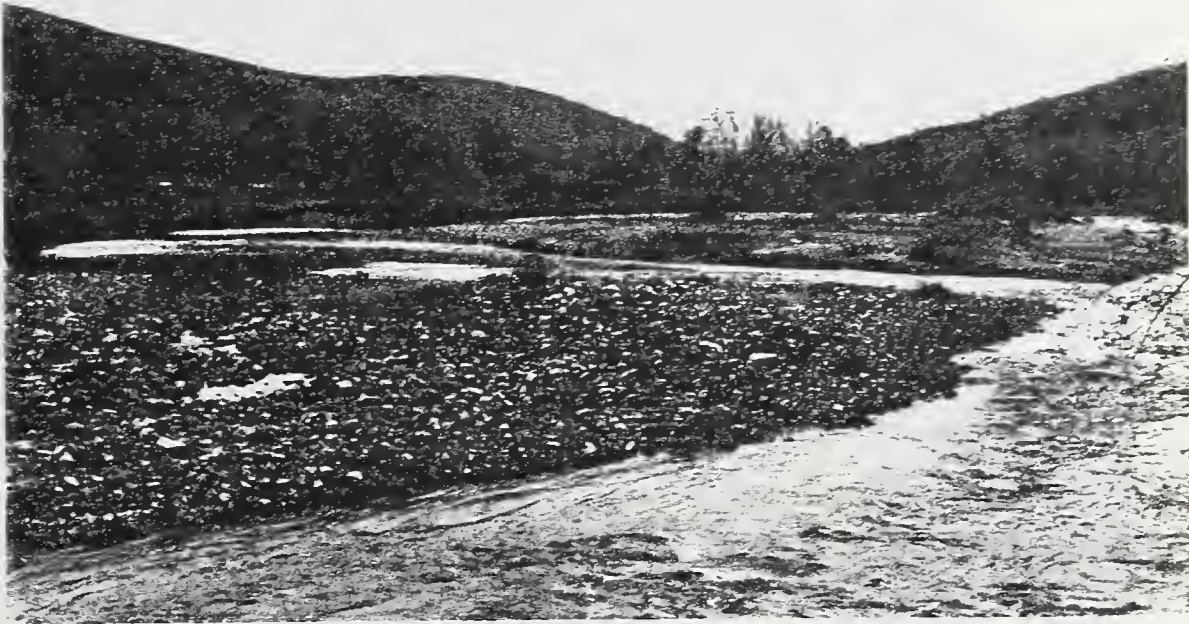
Problem Area #5

Meander streambank erosion and gravel deposits on the right side of the stream.

Location: Streambank erosion southeast of the North River Cemetery
(downstream, of Problem Area #4)

The loss of land due to stream meandering in this problem area may only amount to a value of \$500 per year. To rehabilitate the adjacent cropland the cost in terms of labor, machinery, etc. would equate to about \$500 annually. Total damage for this reach, therefore, averages \$1,000 annually.

Stream degradation will continue with the right streambank eroding and sediment deposited on the inside of the meander. The channel across the inside of the meander will have a tendency to fill in with gravel deposits. The stream system will try to become stable by increasing its meander length. Erosion of the right bank will continue to move into the field and progress downstream with a farmland loss of approximately 1 acre over a 20-year period or an estimated average of 4 feet per year. Downstream of the meander, the deflected streamflow will continue to erode the left bank.

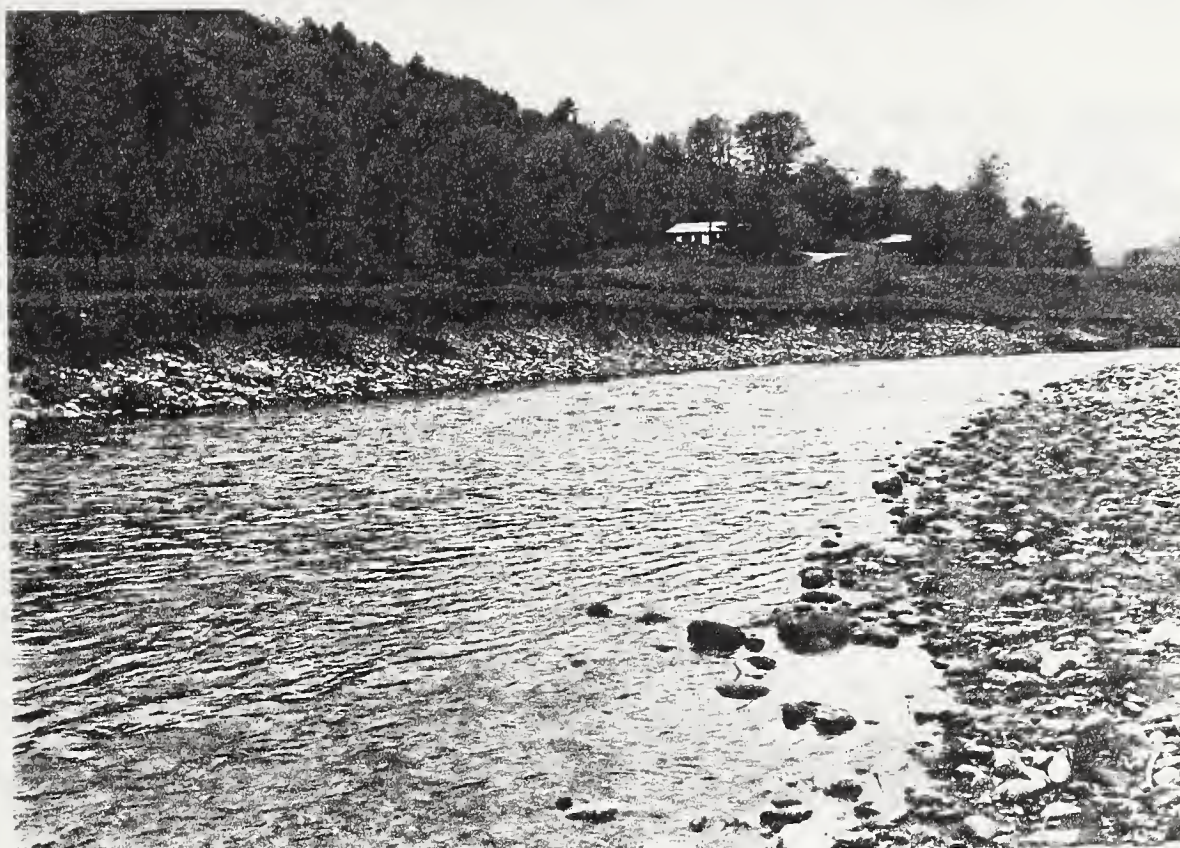
Problem Area #6

Streambank erosion on the right bank upstream of the pumphouse.

Location: Streambank erosion approximately 500 feet upstream of the pumphouse near Central School.

Approximately 1 acre of agricultural land has been lost due to the erosion since 1970. A gravel bar has formed on the left side of the eroded area. Flood flows are directed towards the pumphouse and have caused some erosion in the field.

This problem area suffers a loss of approximately 1/20 of an acre of cropland per year. The economic loss from this loss of cropland is estimated at \$500 annually. If the adjacent farmland was restored, costs are estimated to be \$400 annually. The total economic damage in this area is approximately \$900 yearly.

The loss of the pumphouse could occur within 10 years and cost approximately \$40,000 to replace. The pumphouse and well are a backup water supply. With changes caused by road construction near the present water supply, the well may become the principal source of water. Discounting the future value of the pumphouse replacement cost and amortizing ($8 \frac{7}{8}$ interest rate) it over the coming 10-year period amounts to a cost of approximately \$2,700 per year.

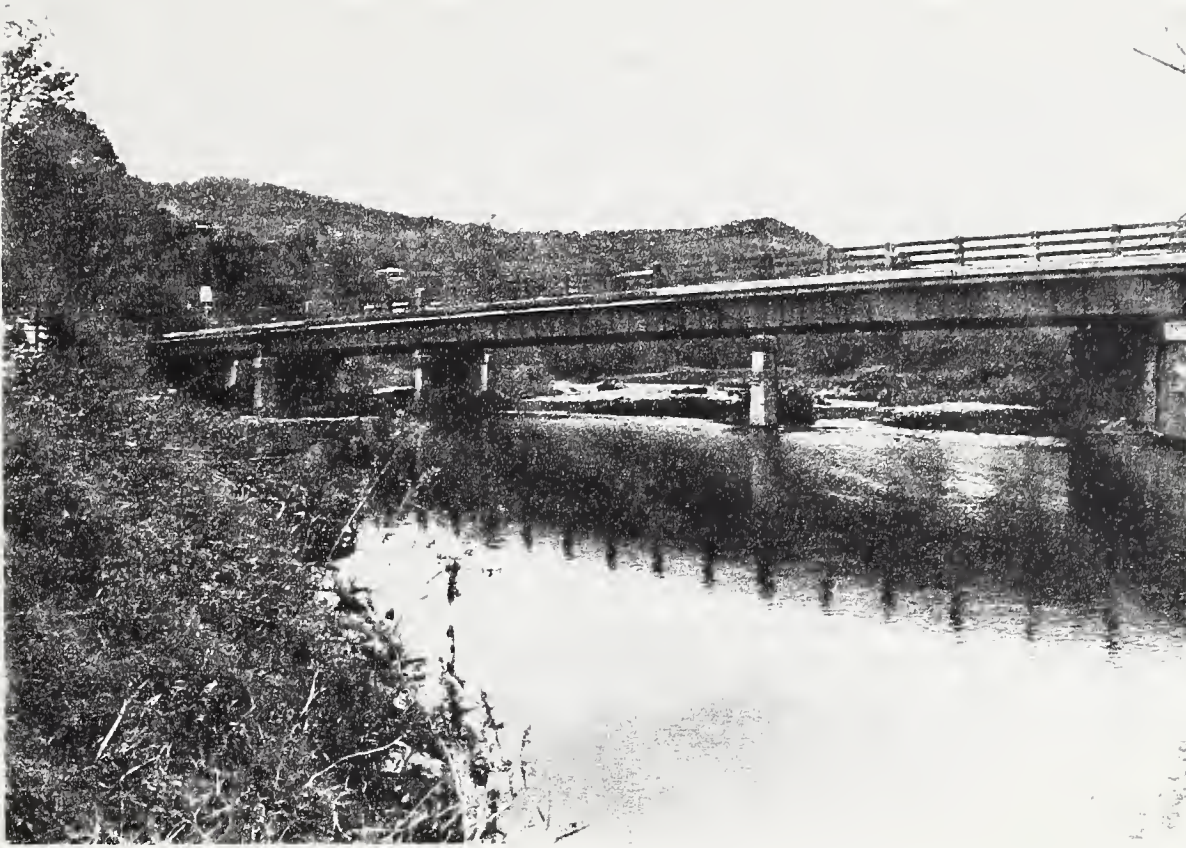
Problem Area #7

Sediment accumulation under the Route 112 bridge.

Location: Route 112 bridge near Central School

Gravel deposits have accumulated underneath and downstream of the bridge. As a result, some of the streamflow is diverted toward the left abutment on the upstream side of the bridge and is eroding the streambank. Similarly, water is directed toward the right bank on the downstream side and causing erosion. The skewed bridge piers impede the streamflow and cause increased sediment accumulation. According to local officials, up until 1979 the town removed approximately 5,000 cubic yards of gravel deposits each year from this area for use on town roads and material accumulated back by the following year. This operation has been curtailed by state regulations since that period. During the snowmelt period floating ice builds up on the sediment deposits at the bridge and creates an ice jam. Several times ice jams have formed and created a potentially hazardous situation. The inability to remove the sediment has worsened the erosion and ice jam problems.

From an economic standpoint, gravel obtained from the stream has a value of approximately \$6/cubic yard. The town has been forced to pay \$30,000 per year since they can no longer use gravel from the stream. This area of Colrain is also subject to possible property flooding during extreme events. The town garage and two homes would suffer floodwater damages. Average annual flood damages in this area are estimated to be \$100 per year.

As part of the stream erosion process, sediment will continue to deposit beneath and downstream from the bridge. The gravel deposits will divert the streamflow and cause additional erosion of the streambanks upstream and downstream of the bridge. Ice jams will form on the sediment deposits more frequently and create potentially hazardous situations. If periodic stream maintenance is not allowed, streamflow will be uncontrolled as it passes through the bridge and the problems will be enhanced.

Currently, River Street becomes flooded during the 100-year frequency storm. As the sediment accumulates to the modeled depth of 4 feet uniformly under the bridge, River Street will become flooded during the 50-year frequency storm. The flooding frequency will approach the 10-year storm for a 6-foot sediment depth under the bridge. Ice jams on these sediment accumulations will increase the flooding frequency.

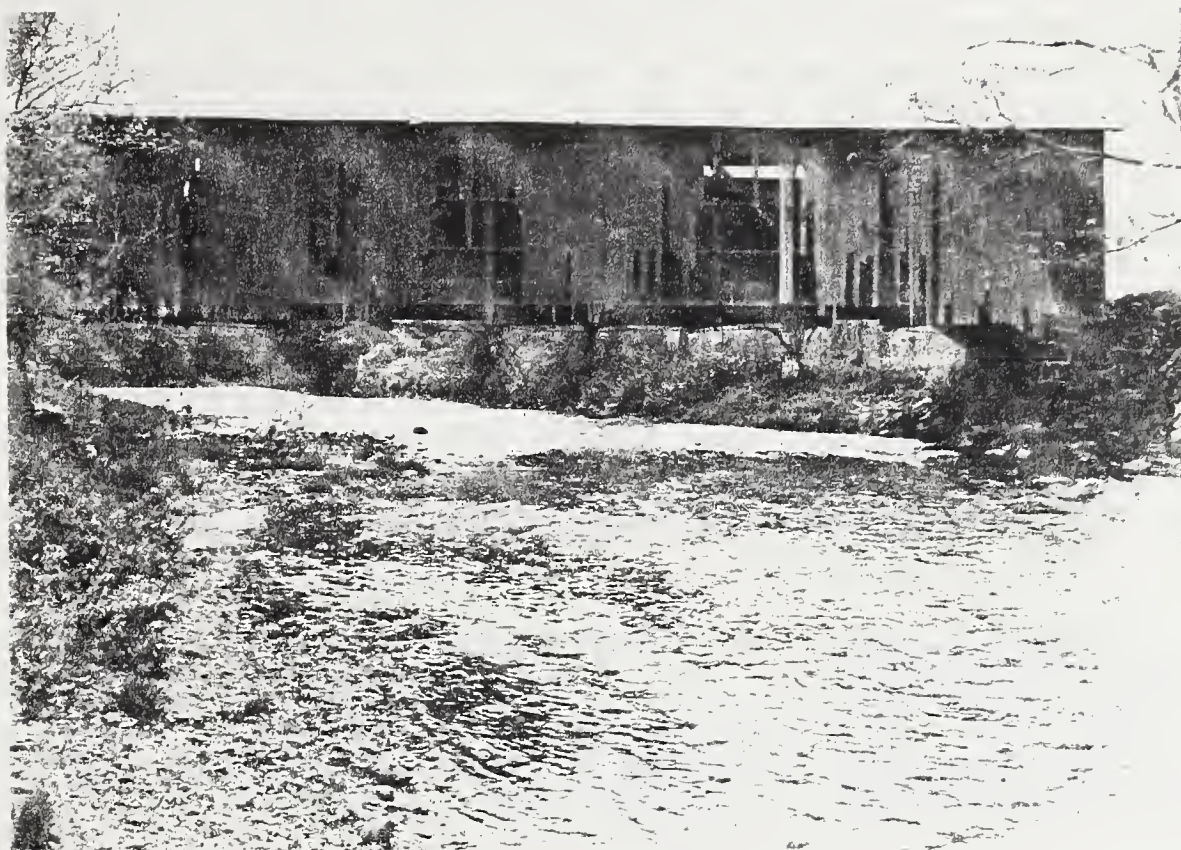
Problem Area #8

Damaged covered bridge looking upstream.

Location: Arthur Smith Covered Bridge on Lyonsville Road across the East Branch North River

The road on both sides of the covered bridge is lower than the bridge deck; as a result, flood flows go around the bridge across the flood plain. Flooding does not pose much of a problem to the bridge, except during major events. Most of the damages to the covered bridge are caused by ice. The problem originates when ice forms behind the dam. During flood flows the flashboards collapse (as designed) at the dam and the water level is lowered with most of the ice remaining above the dam. The remaining ice traps floating ice as it moves downstream. The ice backs up in the stream channel for a distance well upstream of the covered bridge and jams into the bridge decking. When the ice melts in the channel or the floodwater is suddenly released from the dam, the ice is pulled away from the bridge and causes damage to the bridge deck and sideboards. The covered bridge has a unique wooden arch support structure and has significant historic value. This bridge is now preserved as a historical monument and is not used for traffic. The main value of the bridge is for its social values and links with the historic past of the valley. The town has applied for financial assistance from the state and federal government to repair and preserve the covered bridge, but to date have been unsuccessful. It is listed in the National Register of Historic Places. In September 1990, the town removed the covered bridge from across the river and is beginning restoration.

Recent ice jams have occurred in this area on January 26, 1978; March 6, 1979; and February 20, 1981. Photographs taken during these periods indicate that the flood level and ice came very close to the bottom of the bridge at the time of the picture. Based on the maximum discharge recorded at the downstream USGS stream gauge on these days, the 1981 date recorded the highest discharge at an equivalent storm frequency of approximately 20 years. The other two dates had equivalent storm frequencies less than 10 years. Ice jam damage to the covered bridge consists of shearing off of the bottoms of the upstream sideboards, ripping off of the downstream sideboards, damage to the bridge deck and iron braces.

Floodwaters caused by the ice jams flow across the adjacent farmland and cause severe scouring and have even carried away the blacktop of the road. The cost to correct this land damage by using specialized machinery, labor, etc. and prepare this land for regular farm machinery is estimated to cost \$1,000 annually.

Flooding will continue to be a problem when a dam forms at the bridge due to floating debris or ice. Ice will continue to be a problem and may even worsen as sediment accumulates behind the dam and builds up in the channel under the bridge. The ice will continue to damage the covered bridge and eventually cause it to collapse. Maintenance will lengthen the life of the covered bridge.

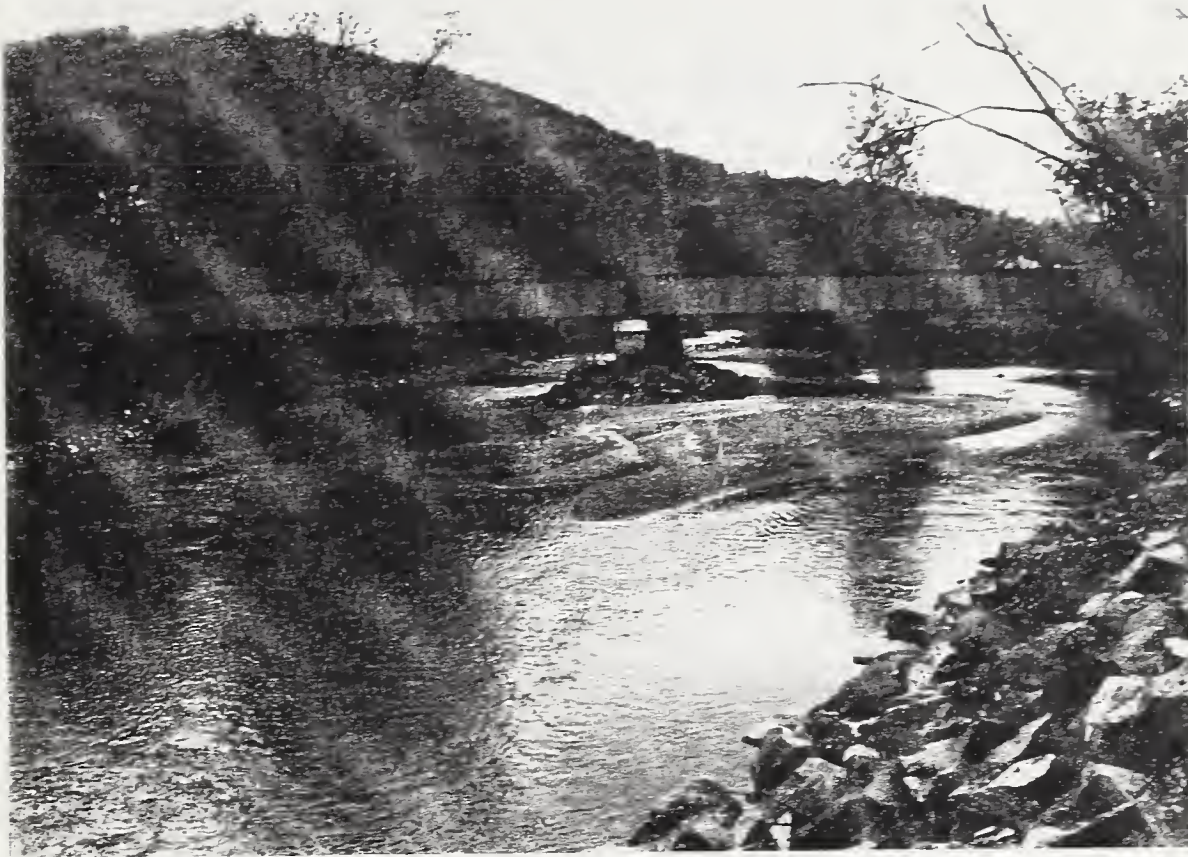
Problem Area #9

Sediment accumulates downstream from Route 112 bridge.

Location: Route 112 bridge below Kendall in Griswoldville.

According to the Flood Insurance Study (based on conditions prior to 1987), the 50-year frequency storm overtops Route 112. In the 10 years prior to 1988 approximately 6 feet of sediment have accumulated under the bridge and its capacity has been reduced. Most of the streamflow was directed towards the left side of the channel along Call Road. Sections of the road embankment had eroded and have been protected with rock riprap. After the April 1987 storm approximately 11,500 cubic yards of sediment were removed from the channel to restore the bridge to its original capacity. The hydraulics of the channel were improved so that streamflow is not directed towards the road embankment. With the cleaned out channel Call Road will be flooded during storms greater than the 50-year event. Sediment has started to reaccumulate under and downstream of the Route 112 bridge.

At this problem area four mobile homes are in the flood plain as well as a gas station and two homes on the east side of the river. Under existing conditions average annual damages are estimated to be \$7,500 per year.

on a hydraulic analysis of sediment accumulation, the flooding frequency of Call Road will approach the 10-year storm for a 6-foot sediment depth under the bridge. The sediment deposits may divert the streamflow which may cause streambank erosion upstream and downstream of the bridge. There is evidence of this occurring in the past, because the downstream left streambank along Call Road has been protected with rock riprap.

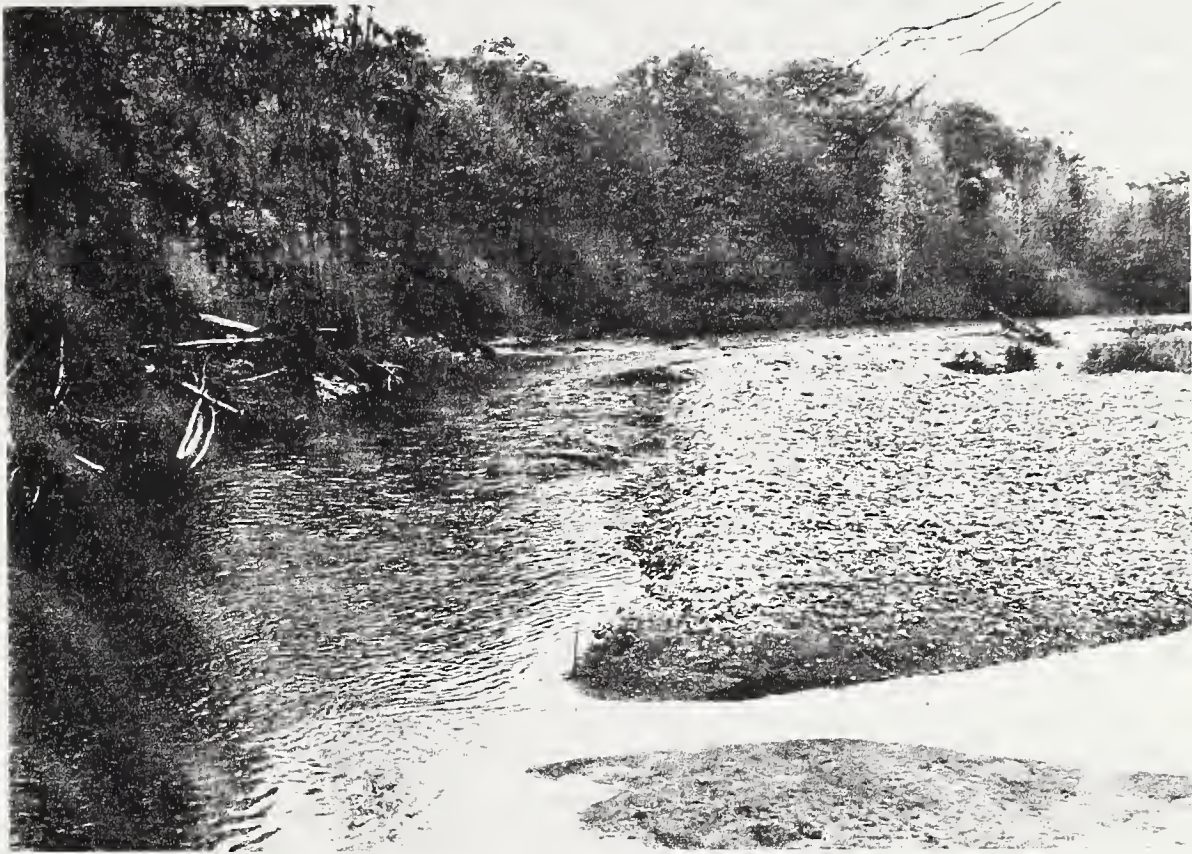
Problem Area #10

Gravel bar accumulation looking upstream from Call Road.

Location: Approximately 2,000 feet downstream of the Route 112 bridge in Griswoldville

There is a potential loss of farmland in this area, perhaps as much as 1/20 of an acre per year, possibly translating to an annual land loss cost of \$500. The cost of repairing damages to the fields from gullying and infertile overwash is estimated to be an additional \$500. Potential total damages in this area are estimated to be \$1,000 annually.

estimated loss of 1 acre every 20 years. There will be a tendency to form an island between the existing channel and overflow channel. The streamflow will have a direct impact on the Call Road bank and may cause erosion of the left streambank. If the overflow channel becomes the main channel for the stream, there will be less threat of damage to the Call Road streambank and sediment may accumulate along the toe to provide additional protection.
